## Restoring the Function of 30 Lecture Hall Seats by Fixing Used Furniture on Campus

Don Radius Gerald Kabo<sup>1\*</sup>, Josef Arnoldul Johny Sumajouw<sup>2</sup>, Carter David Erenst Kandou<sup>3</sup>, Denny Boy Pinasang<sup>4</sup>  
Politeknik Negeri Manado

This project aimed to restore the function of 30 lecture chairs with integrated writing desks at Manado State Polytechnic. Progress reports and notes K01-K30 were analyzed to categorize damages, actions, and results of function inspections. Work from June 8 to September 28, 2026, recorded the replacement of upholstery on all units; 21 units had seat upholstery issues and 17 units had backrest upholstery issues, with eight units having both. Thirteen actions were recorded in June, five in July, four in August, and eight in September. All 30 units showed positive function results. Findings indicate 100% coverage on physical actions, while program reports showed 80% progress. Signed test sheets, cost data, and placement evidence provided a standard safety assessment and utilization impact

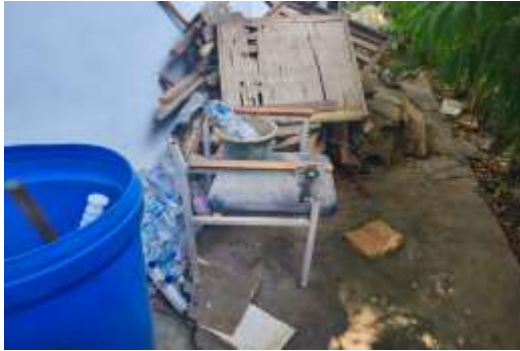
Condition of the furniture area in the  
report documentation

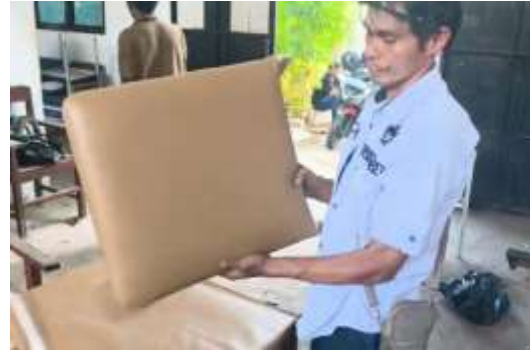
Documented work on coating  
components
